Evaluation of the Impact of Milking Machine Design on Teat Swelling

William Gehm
LR Gehm, LLC
9502 NYS Rt. 79
Lisle, NY 13797

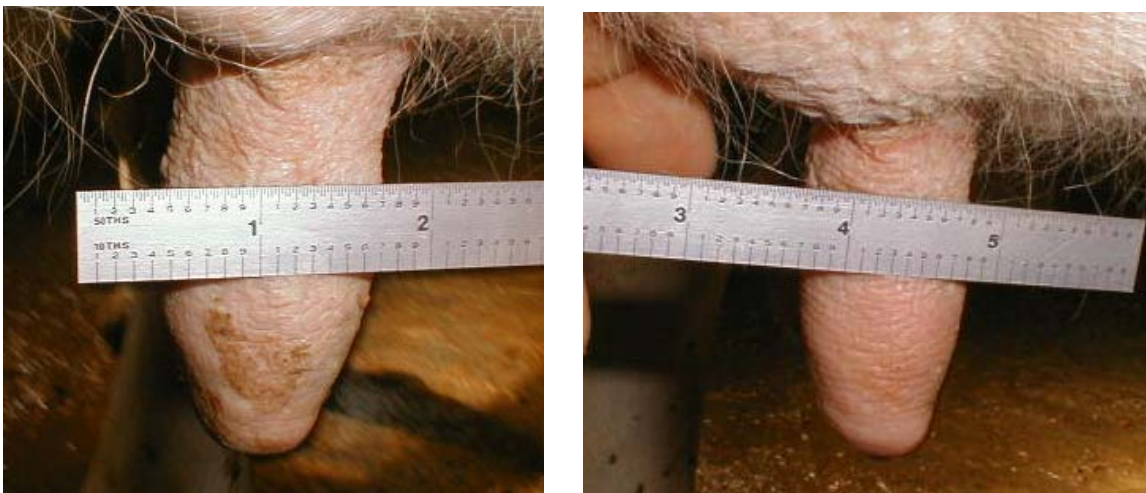
Figure 1

The measurements of the teats milked with the CoPulsation™ Milking System showed that in all cases the external diameter of the teat had reduced. The average reduction was approximately .1 inch in diameter. An example is shown in Figure 1.

Before milking: 1.2 inches

After milking: 1.0 inches

External teat conditions were optically recorded just prior to teat prep for milking and immediately following machine removal. A steel rule scale was located near the teat in the same location and photographed with a digital camera at the same distance to record the before and after teat condition. This method is similar to that used in the machined parts industry known as optical comparison. An Optical Comparator is used for measuring details of small or complex machined parts. Maintaining the steel rule scale in the same position for

Photographs of before and after teat conditions were used to determine the size of the external diameter of the teat. The external diameter of the teats before and after milking were compared to determine the relative change.

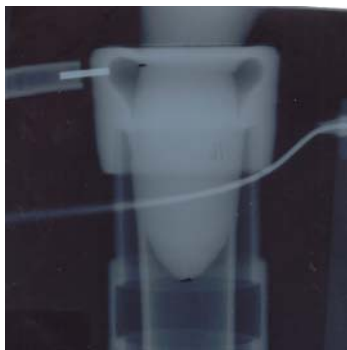
This stands in contrast to the results reported by O'Callaghan in the Irish Veterinary Journal (2) in which all teats milked with conventional milking machines experienced swelling during the milking process. The O'Callaghan study (2) showed that the average teat swelling ranged from approximately .46 mm to 1.0 mm. O'Callaghan had also documented the condition of the teat in a liner in a paper (3) that shows the extreme teat swelling that occurs with a DairyMaster milking system. This swelling is consistent with the results of the increased teat diameter at the conclusion of milking with a conventional milking machine. The x-ray showing that teat swelling condition from the O'Callaghan paper is shown in Figure 2.

Figure 2
x-ray of large bore liner
